Overview of the First Quarter 2020 Surveillance and Maintenance Report for the Rocky Flats Site, Colorado

January-March 2020

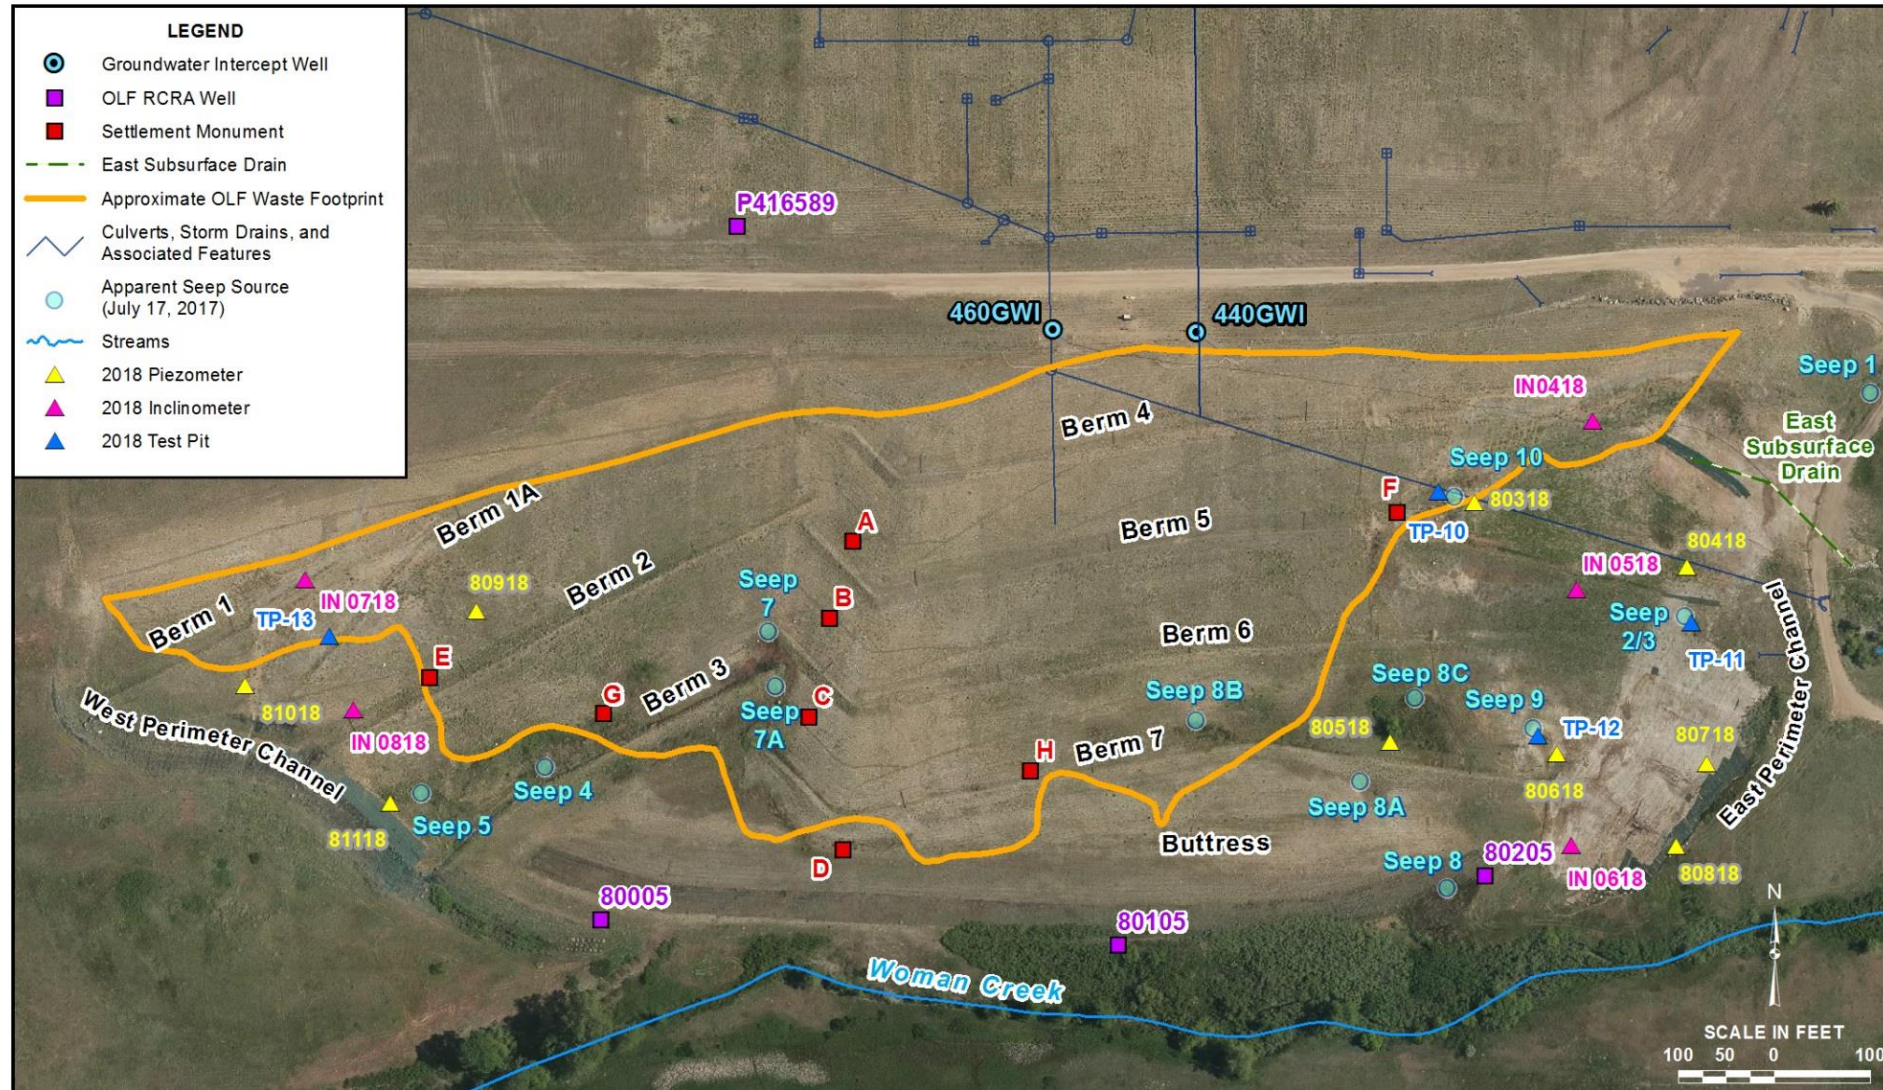
OLF (continued)

- Monthly and weather-related inspections
 - January 15, February 20, and March 18, 2020
 - Observed 5-foot-long and 3-inch-deep tension crack above berm 4 in January; addressed by subcontractor
 - Seep 2/3 excavated and Seep 8C partially covered during maintenance activities
- Surveyed settlement monuments on March 2, 2020
 - Vertical settling was within design limits
- Mobilization and site preparation for slope stabilization project in September
- Drilling progress in February was slowed by multiple snow events and periods with high winds
- By the end of the quarter, 212 of 267 tie-back anchors were installed, tested, and locked off
- East and West Interceptor Trenches neared completion

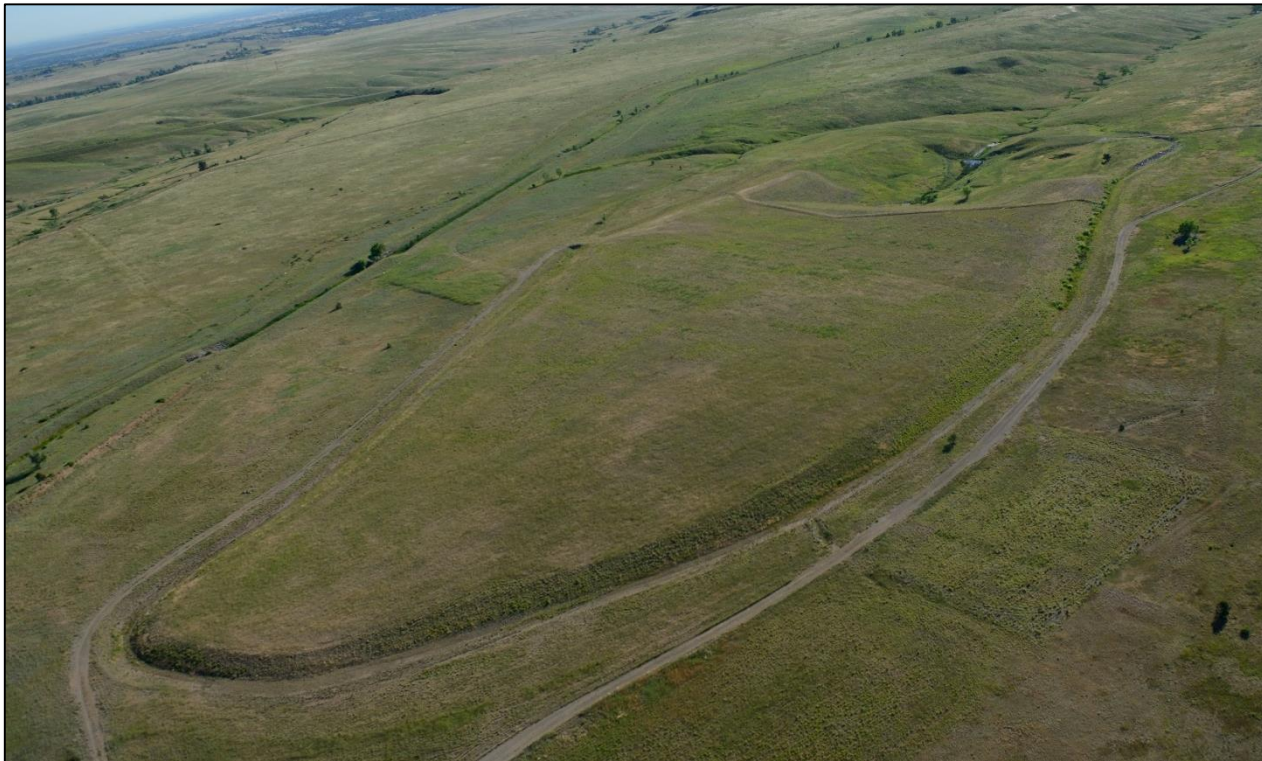
- Performed quarterly inspection on March 3, 2020
- Landfill is in good condition; performed minor maintenance at the PLFTS outlet

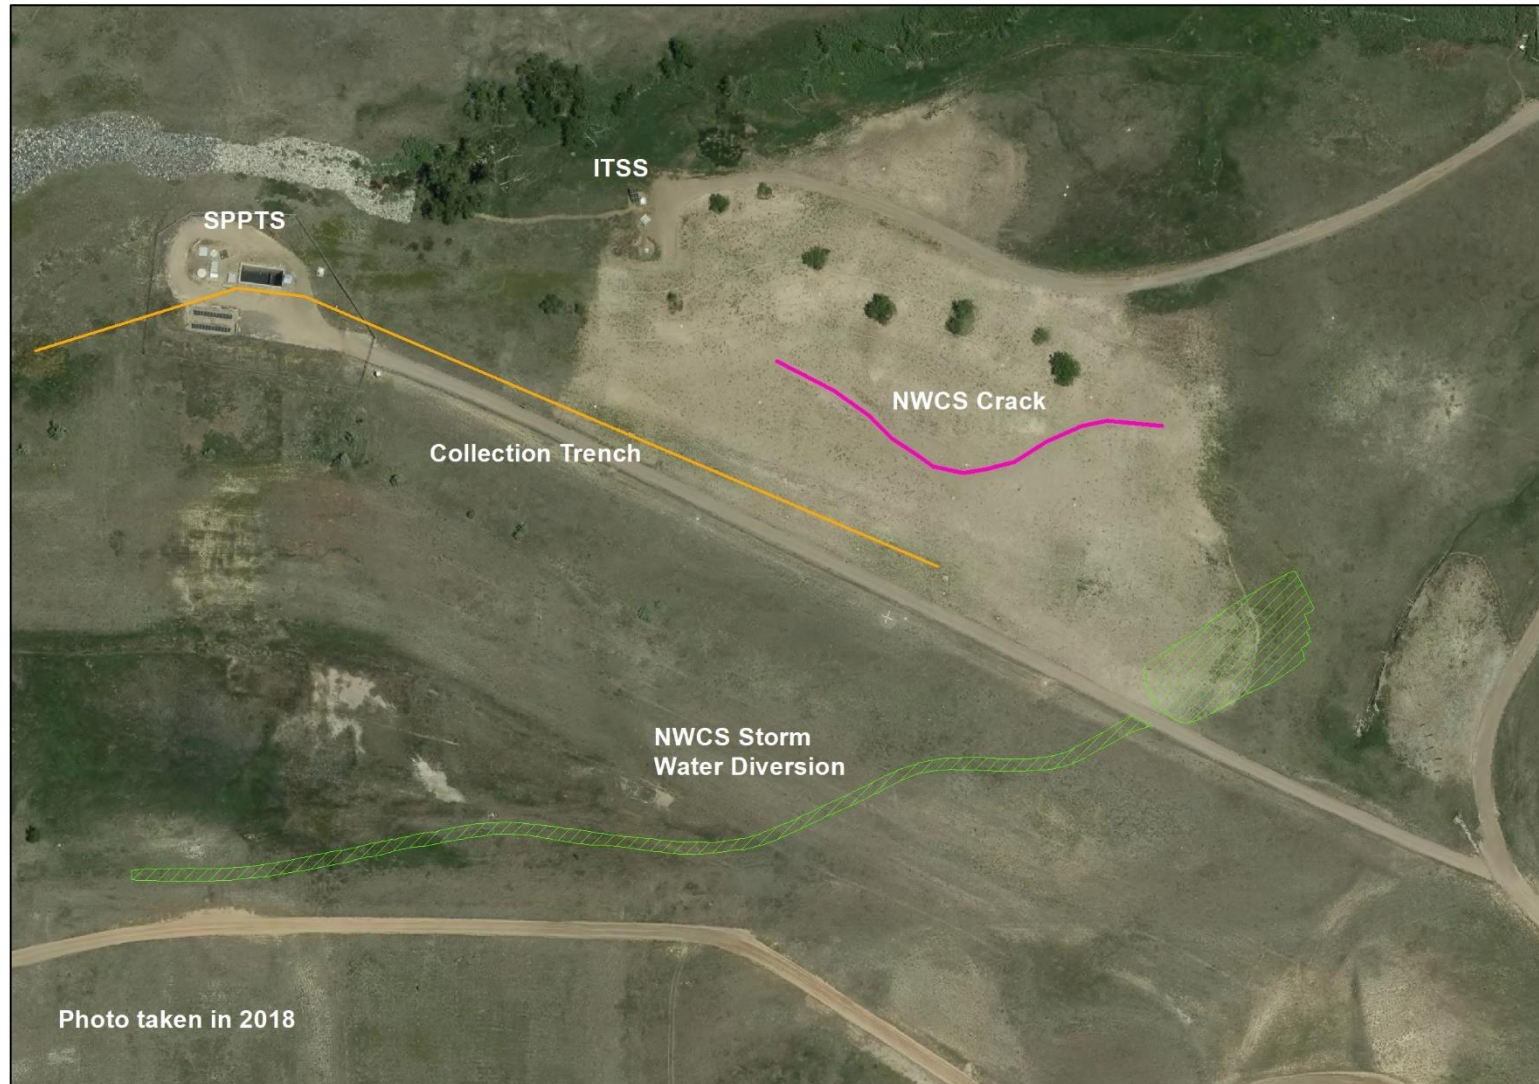
North Walnut Creek Slump (continued)

- Continued data collection from piezometers where possible
 - RFMLA monitoring points in this area are not impacted
- Slump monitoring points were surveyed on January 7, February 6, and March 2, 2020
 - Maximum movement since baseline (September 5, 2017) was approximately 2 1/2 feet vertically
 - Scarp crack largely remained closed due to elk traffic in the area; open 1/4 to 1/2 inch in places
 - Small cracking continued in the Interceptor Trench System Sump access road
